Scope of Work for Rehabilitation of Abushaka PHCU

Site Location: Abushaka Boma,

Date: 28th, December ,2023

SUMMARY OF SCOPE OF WORK AND PHOTOS FOR REHABILITATION OF ABUSHAKA PHCU

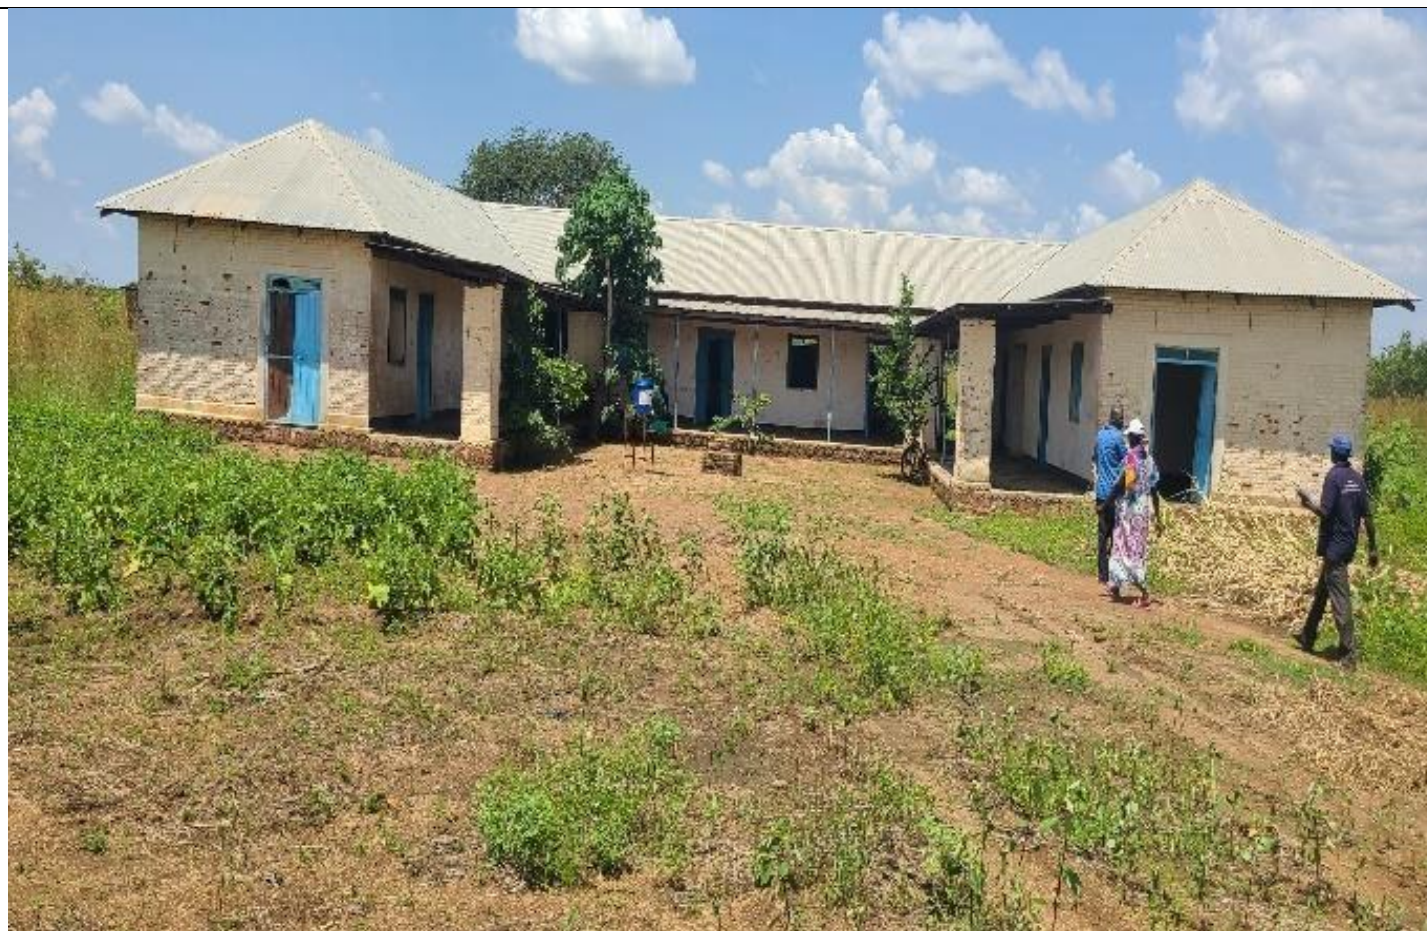
Fig:1. Showing Abushaka PHCU front view and external wall surface condition

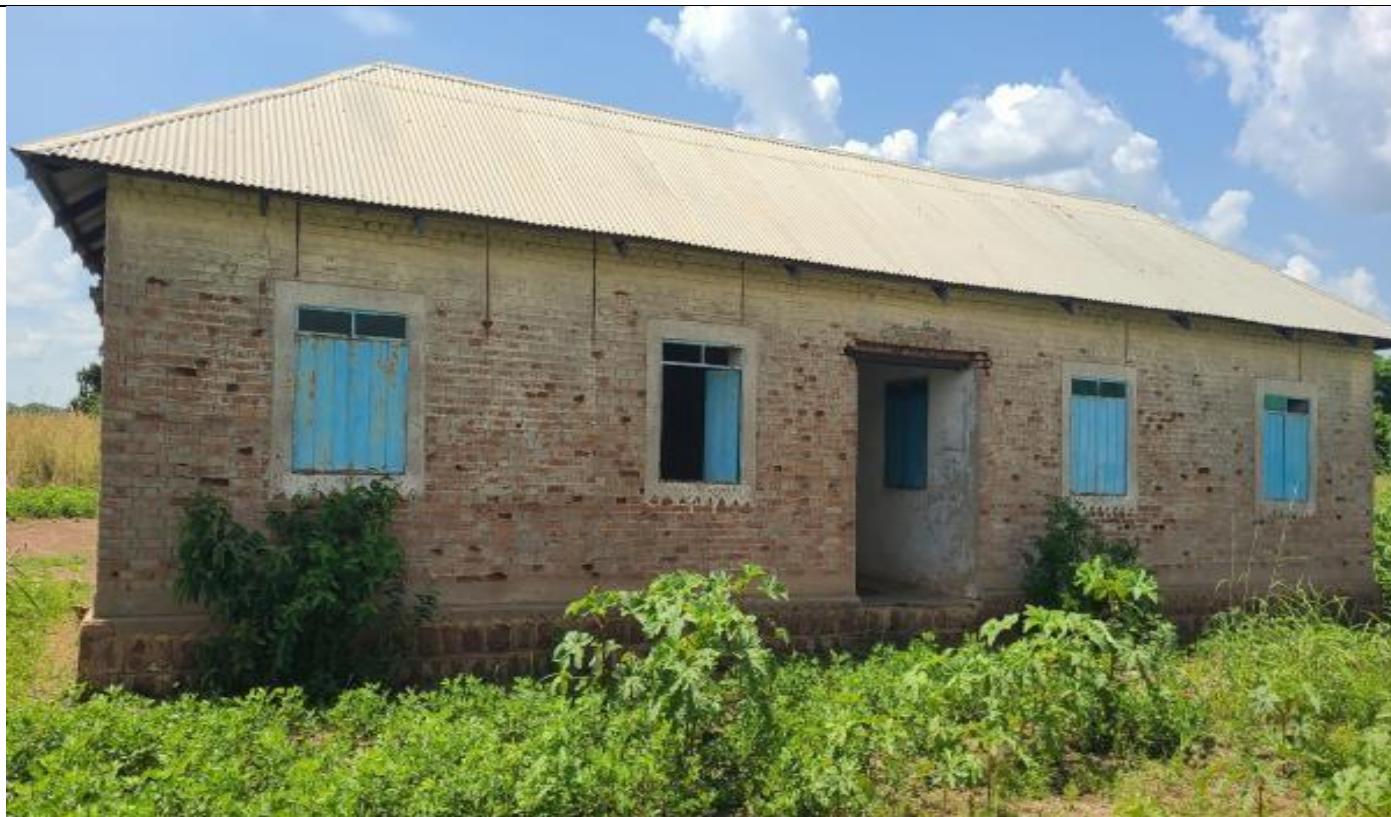
Fig: 2. Showing rear section condition.

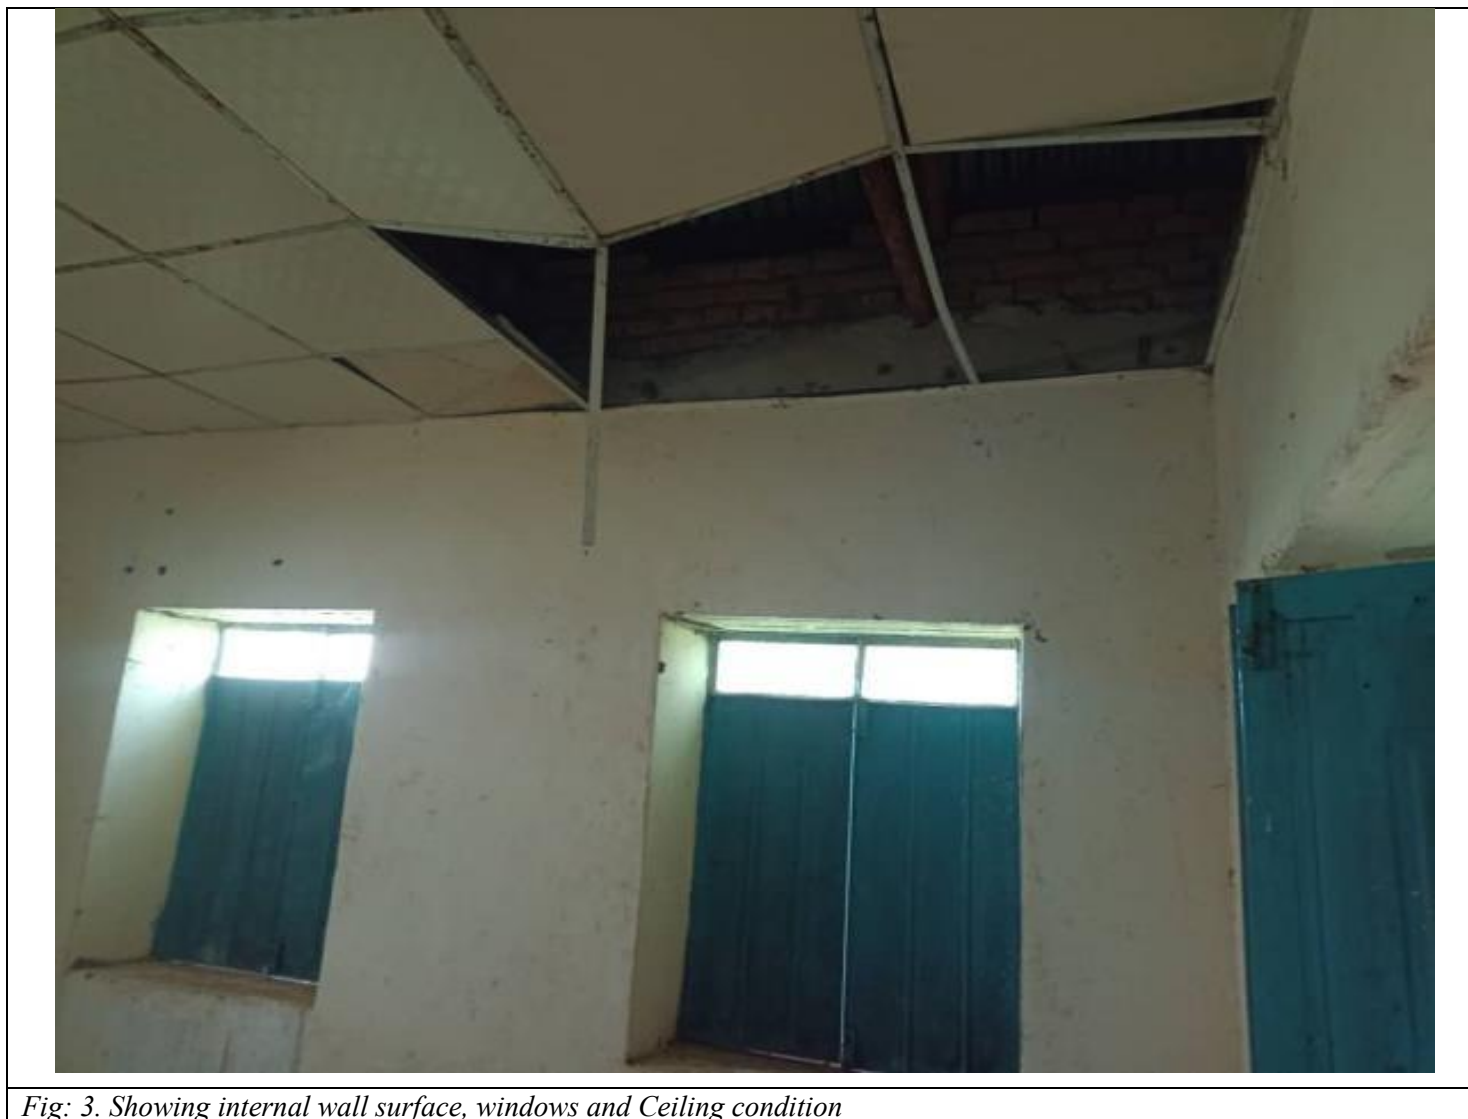
Fig: 3. Showing internal wall surface, windows and Ceiling condition

<ul style="list-style-type: none"> • Rehabilitate existing windows by replacement of window shutters, hinges, locks, louvers, worn out frames, provide 2-3 coats of anti-rust paint to door of 23 windows in number metallic windows. • Fixing of wooden Fascia board. • Reinstallation of gypsum Ceiling board, • Render external wall surfaces with cm plaster render to receive weather guard paint or rough cast finishes as specified in the BoQ. • Clean the internal dirty wall and fill up worn out spots/cracks of the internal wall surfaces.re-paint internal surfaces as per the specification in the bill of quantities. • Installation of rainwater drainage system (gutters and down pipes). • Installation of solar power system and provide furniture (Desk, chairs and waiting benches).
Bessilia		Abushaka PHCU	Rehabilitation of Abushaka PHCU Store	<ul style="list-style-type: none"> • Replacement of all floors by installing a 100mm thick floor slab reinforced with BRC and 50mm thick screed (4x4m store). • Replacement of 01 metallic windows (1x1.3m) • Installation/replacement of metallic doors, 1 in number (1x2.1) • Replacement of roof cover/sheets and trusses • Plastering and rendering of internal and external wall surfaces respectively. • Painting of internal and external wall.

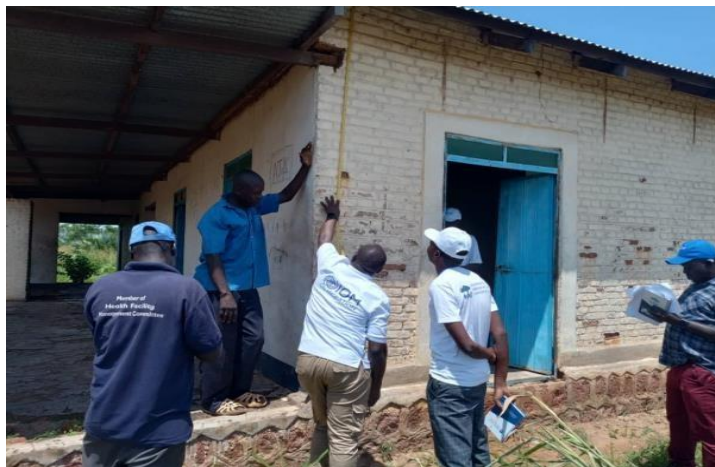
Fig. 5. Showing condition of external Wall

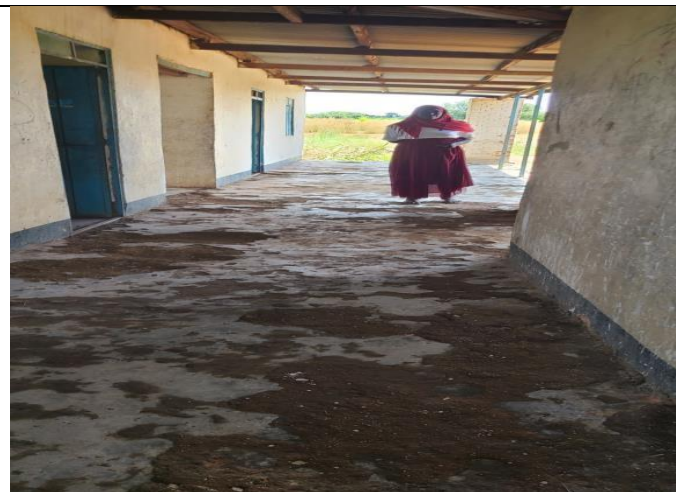
Fig. 6. Showing Abushaka verandah condition
