YONTOOY WATER TREATMENT PLANT FLOOD DAMAGE ASSESSMENT REPORT

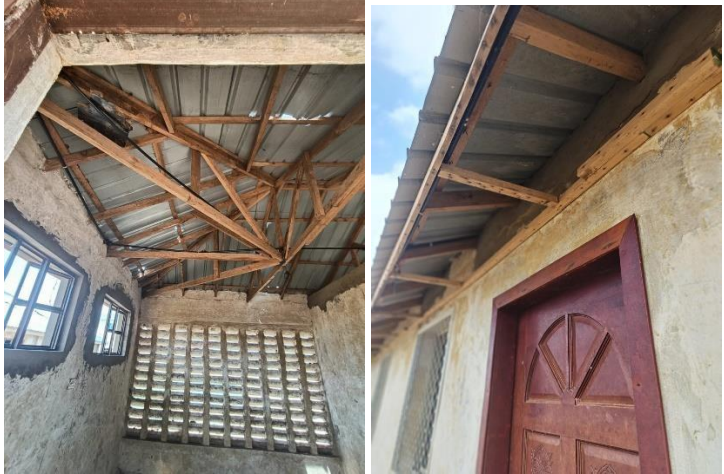
Photos indicating extent of damage	Observations on defects	Proposed Corrective Measures
1.	Roofing (iron sheets and timber)

<p>Damaged and torn Iron sheets</p> <p>Roofing timber- may have been compromised by the prolonged wetting and uneven drying which alternately caused the timber to swell and shrink. Warped timber observed.</p>	<p>Removal and replacement of iron sheets</p> <p>Removal and replacement of the timber.</p>
2.	Ceiling

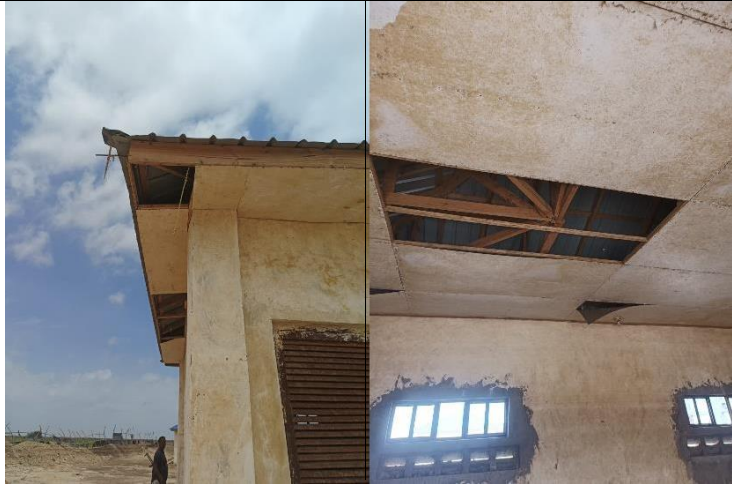
<ul style="list-style-type: none"> • Deformations observed on ceiling boards causing some sections to also collapse. • Boards discoloration 	<p>Removal and replacement of the ceiling board and ceiling timber.</p>

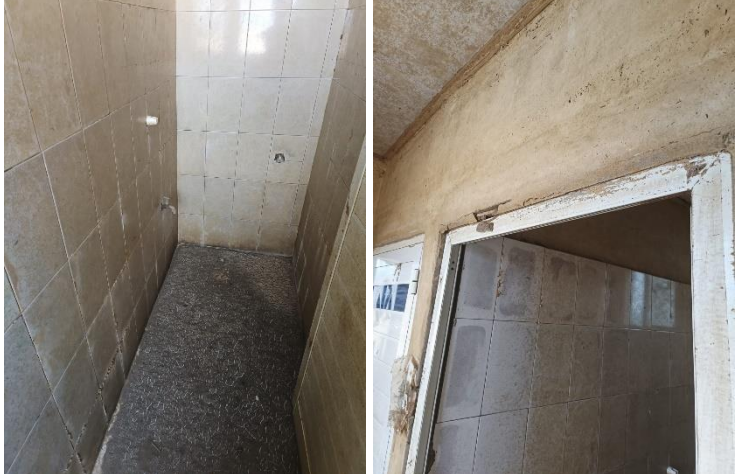
Photos indicating extent of damage	Observations on defects	Proposed Corrective Measures
3.	Tile works

<p>Prolonged exposure to water leading to reduced adhesive bond between floor/wall and tiles evident by wobbling tiles.</p> <ul style="list-style-type: none"> • Discoloration on tiles • Hollow sound on tapping • Observed wetted areas between tiles and floor/wall 	<p>Removal and replacement of tiles</p>

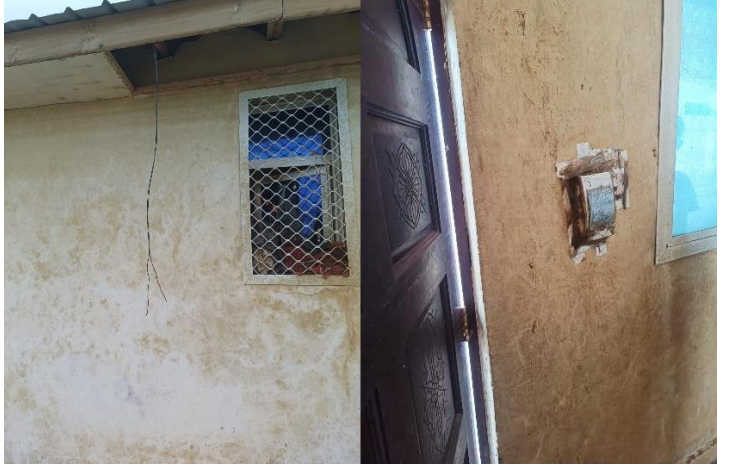
4.	Electrical and plumbing fittings

<p>Functionality of fittings and wires cannot be guaranteed due to exposure to moisture which may have reduced their integrity, which poses a risk of short-circuiting, electrical fire, shock and electrocution. Observations included;</p> <ul style="list-style-type: none"> • Switches failing to turn on and off, non-functional panel boards and switchboards • Bulb holders, electrical wire conduits fallen off • Electrical wires and conduits damaged and cut off 	<p>Removal of currently installed wires and electrical fittings. Ensuring conduits embedded within wall dry off. Reinstalling of damaged conduits and all wires and electrical fittings. This will include plumbing works which are likely to be damaged or clogged.</p>

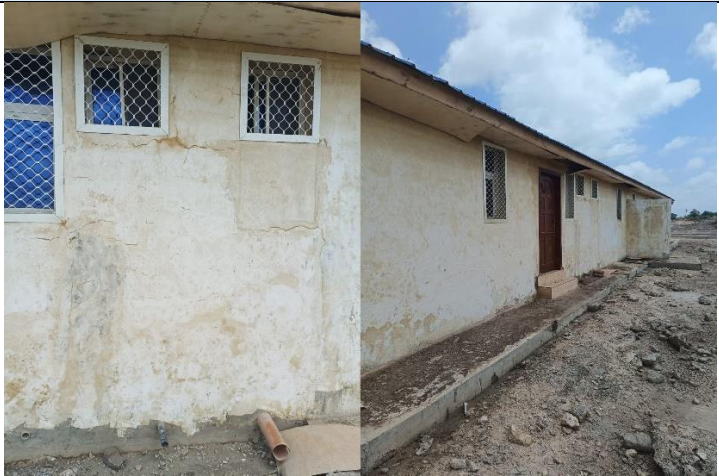
<p>Walls (Plaster and Paint)</p> <ul style="list-style-type: none"> • Salt water resulted to damage to plaster, developing from the borders of a pattern of cracks possibly caused by drying shrinkage • Drying shrinkage at joints. <p>Flaking and discolored Paint</p>	<p>Repair on affected areas through exposing the cracks and treating with mortar and re-plastering.</p> <p>Cleaning and scrubbing off old paint and repainting.</p>

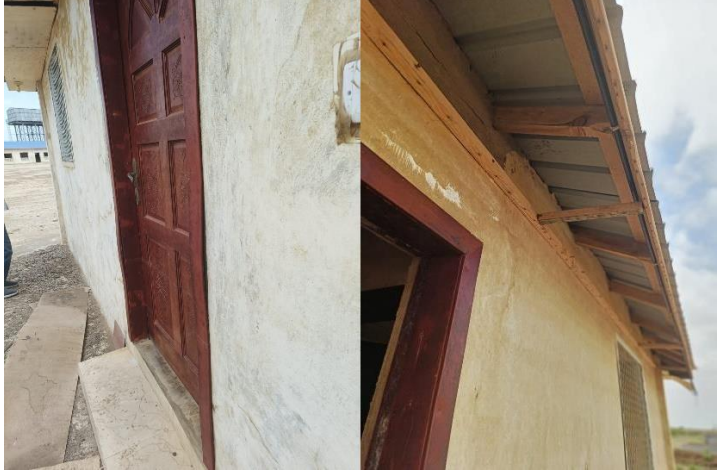
5.	Timber Doors

<p>Timber Doors have been compromised by the prolonged wetting and uneven drying which alternately caused the timber to swell and shrink.</p> <ul style="list-style-type: none"> ➤ Doors were observed to be stuck and couldn't open easily without being forcefully opened ➤ Also evident from warping observed on frames 	<p>Complete removal and replacement of doors</p>

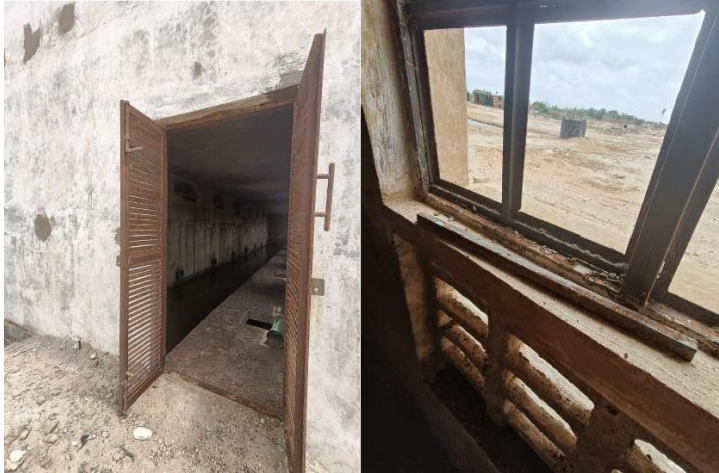
6.	Metal doors and Windows

<p>Metal works seem to have greatly rusted due to degradation resulting from excessive corrosion, evident from ease of breakage. Corrosion has affected inner parts for hollow sections.</p>	<p>As a long-term measure and to avoid short life on metal works, replacement of the affected metal doors and windows recommended</p>

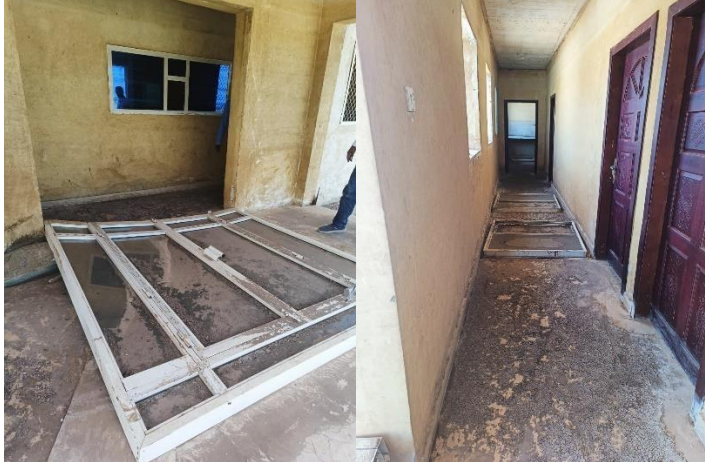
7.	<p>Aluminum Windows and Doors</p>

<p>Force exerted by water has caused external doors and windows to loosen leading to some falling off. Notable damages include;</p> <ul style="list-style-type: none"> ➤ Dirt trapped between windows and clogging mosquito mesh ➤ Bond between windows and wall seem to have been affected causing windows to loosen ➤ Access door to administration building damaged ➤ 12No. windows observed to be damaged 	<ul style="list-style-type: none"> ➤ Replacement, of mosquito mesh of all windows. ➤ Removal of all windows cleaning and reinstallation. ➤ Replacement of damaged 12No. windows and 1no. door accessing the administration building

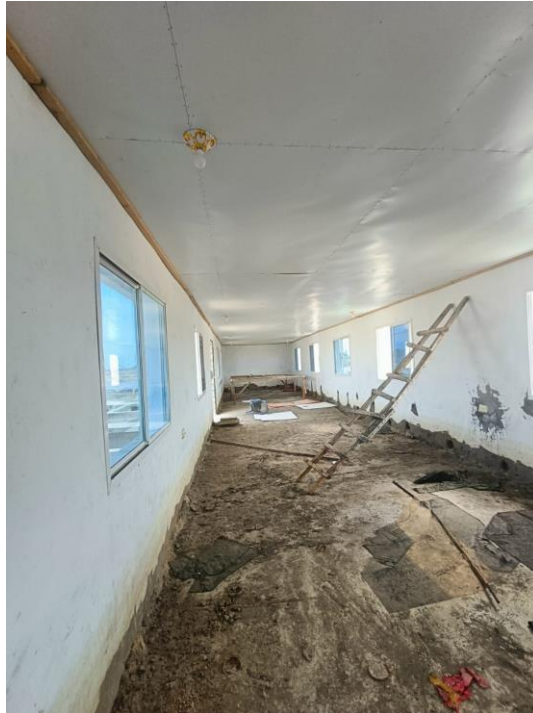
Photo 1: Interior of the Filter Gallery Control Room

1. Floor and paint works up to about 1m from the floor level- This will require repainting works to be done up to the affected section and replacement of tiles.
2. It was observed that animals including snakes and bats had taken habitat inside the ceiling of these structures during this period - This will require removal of ceiling, cleaning, sanitizing the areas and re-installation of the ceiling.

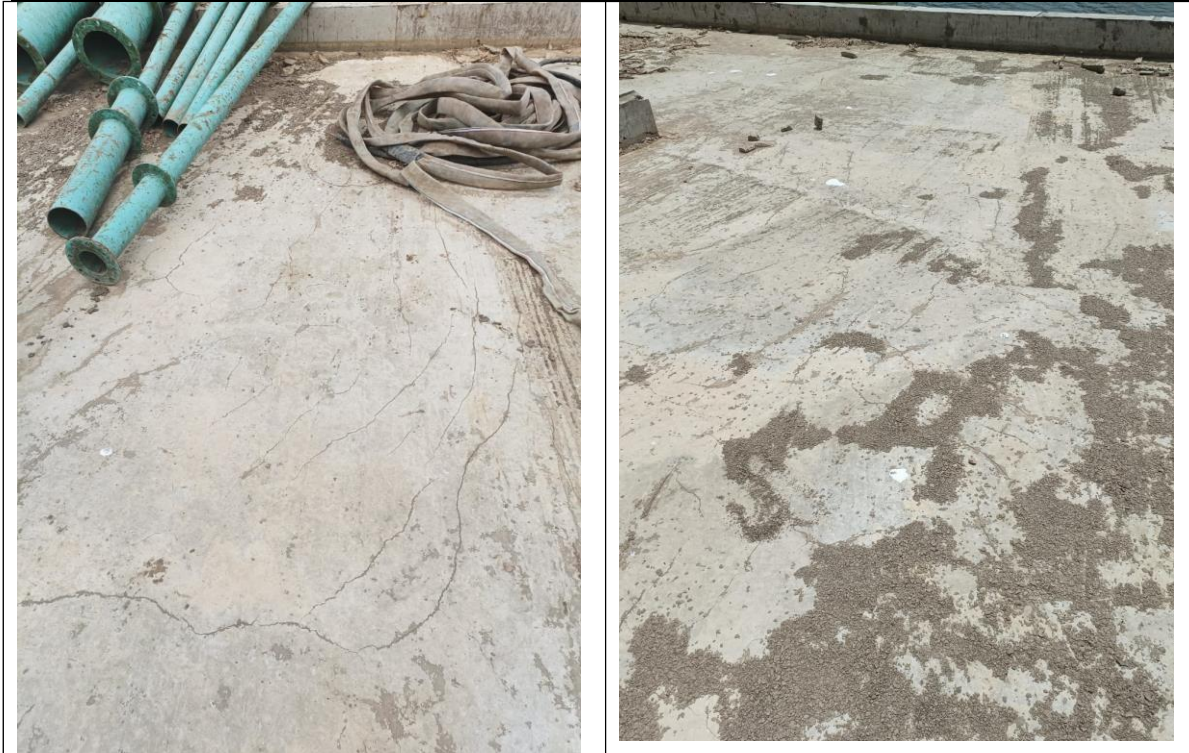
From the visual assessment, concrete cracks appeared on top roof slab of the 1000m³ Clear Water Tank. This is likely to have occurred due to overloading of the slab due to excessive weight from floodwaters.

Photo 2: Cracks at top of Roof Slab on 1000m³ Clear Water Tank

Further assessment will be carried out after the water in the tank is pumped out and the soffit of the slab and sidewalls are assessed. Water tightness test will also be carried out to ensure no leakage joints have formed

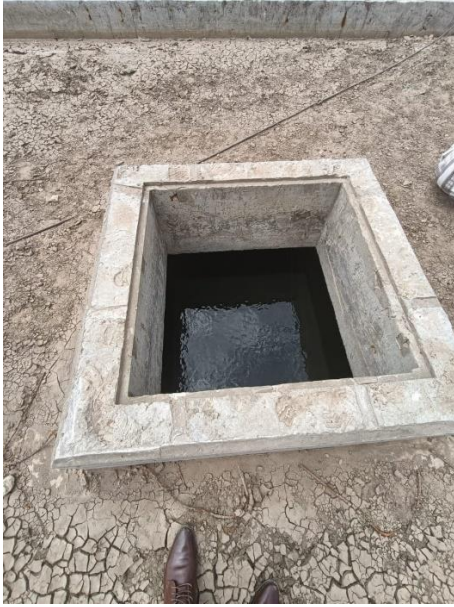
Photo 3: Water filled 1000m³ Clear Water Tank

These flooded areas are also inhabited by fish and snakes, works will involve pumping out the water and discharging to the river since pumping to nearby area will result to pools of water and probable flooding back at the site, scrubbing off molds and sanitizing the 1000m³ Clear Water Tank and the sedimentation tank. The estimated volume of water at these flooding sites is approximately 4500m³.

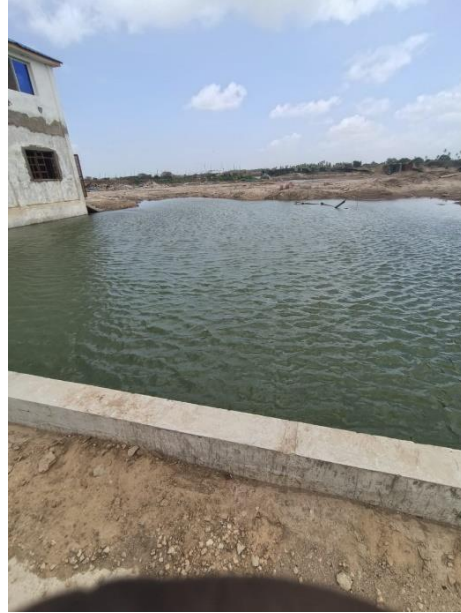
Photo 4: Flooded area at the excavated area around the pump house and clear water tank

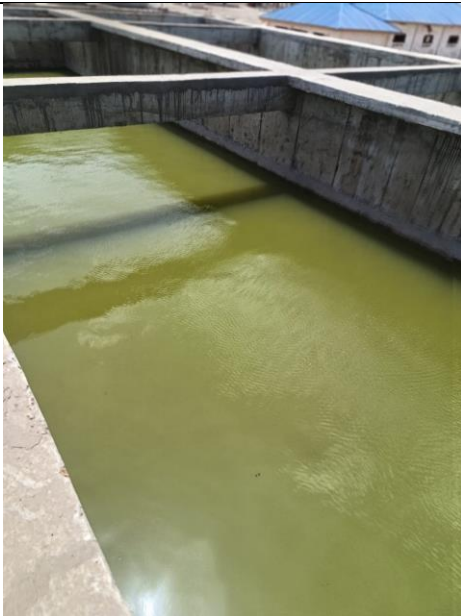
Photo 5: Flooded sedimentation tank

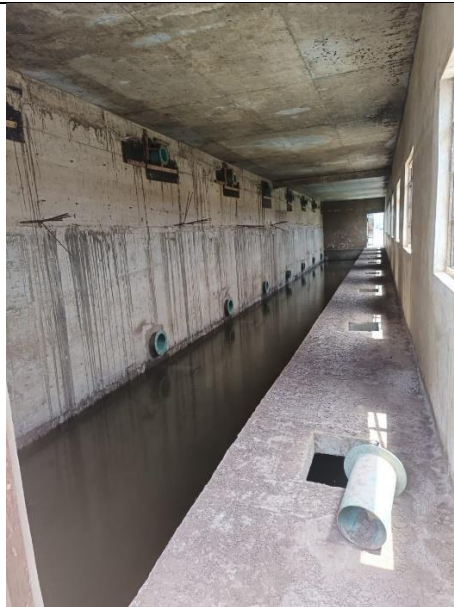
Photo 6: Flooded area at the filter gallery
