# **IOM TYPHOON HAIYAN (YOLANDA) RESPONSE**

## **Assessment of Usability of Designated Evacuation Centres in case of Typhoon**

**MERCEDES, EASTERN SAMAR, PHILIPPINES**

**Jan 2014**

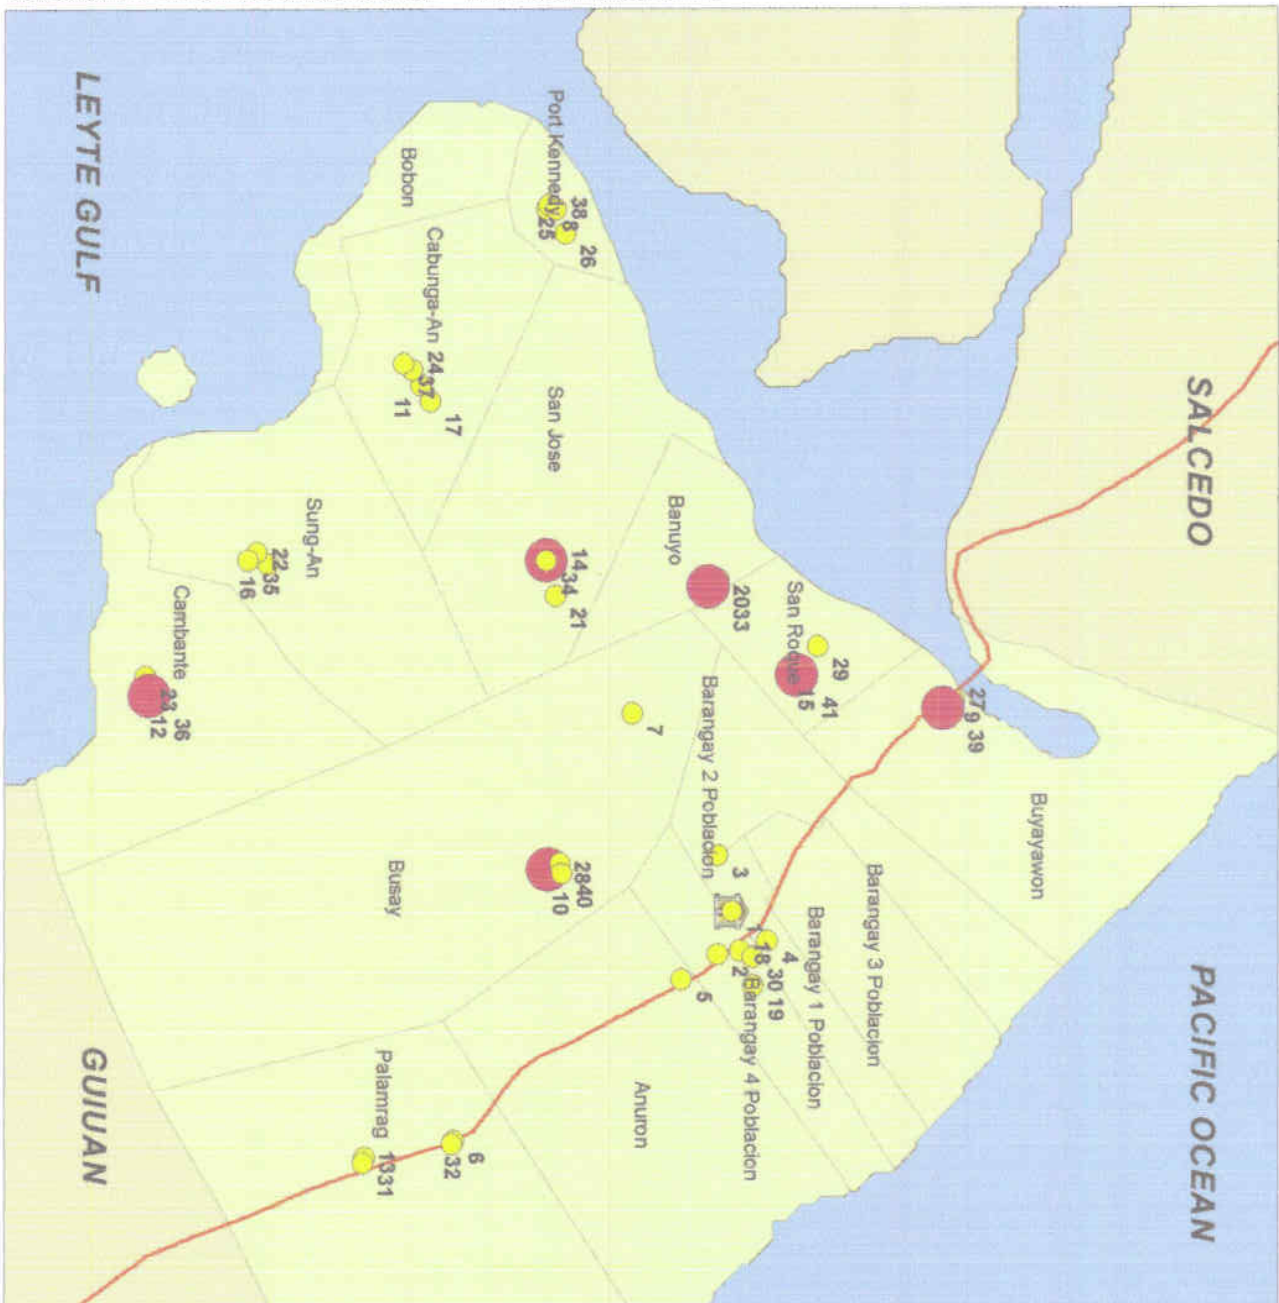
# DESIGNATED EVACUATION CENTERS IN MERCEDES (Pre - Typhoon Yolanda)

No.	Barangay	Evacuation Center
1	Buy 2	Marceles Poblacion Hall/Venue for event
2	Buy 1	Buy 1 Hall
3	Buy 2	Buy 2 Hall
4	Buy 3	Buy 3 Hall
5	Buy 4	Buy 4 Hall
6	Buy Anuron	Buy Anuron & Main Service Station
7	Buy Banuyo	Buy Banuyo Hall
8	Buy Bobon	Buy Bobon Hall
9	Buy Buyayawon	Buy Buyayawon Hall
10	Buy Buyayawon	Buy Buyayawon Hall
11	Buy Cabunga-An	Buy Cabunga-An Hall
12	Buy Cambarte	Buy Cambarte Hall
13	Buy Cambarte	Buy Cambarte Hall
14	Buy San Jose	Buy San Jose Hall
15	Buy San Roque	Buy San Roque Hall
16	Buy San Roque	Buy San Roque Hall
17	Buy Cabunga-An	Buy Cabunga-An Health Center
18	Buy 3	General School
19	Buy 3	Mercedes National High School
20	Buy Banuyo	Buy Banuyo Elementary School
21	Buy San Jose	Buy San Jose Elementary School
22	Buy San Jose	Buy San Jose Elementary School
23	Buy Cambarte	Buy Cambarte Elementary School
24	Buy Cambarte	Buy Cambarte Elementary School
25	Buy Banuyo	Buy Banuyo National High School

No.	Description	No. of Buildings
1	Destroyed - Not Usable	0
2	Damaged - Not Usable	55
3	Not Damaged - Usable	9
TOTAL		64
